StayDry[®] Summary of Testing

Design Qualification Tests, Results, and Analysis

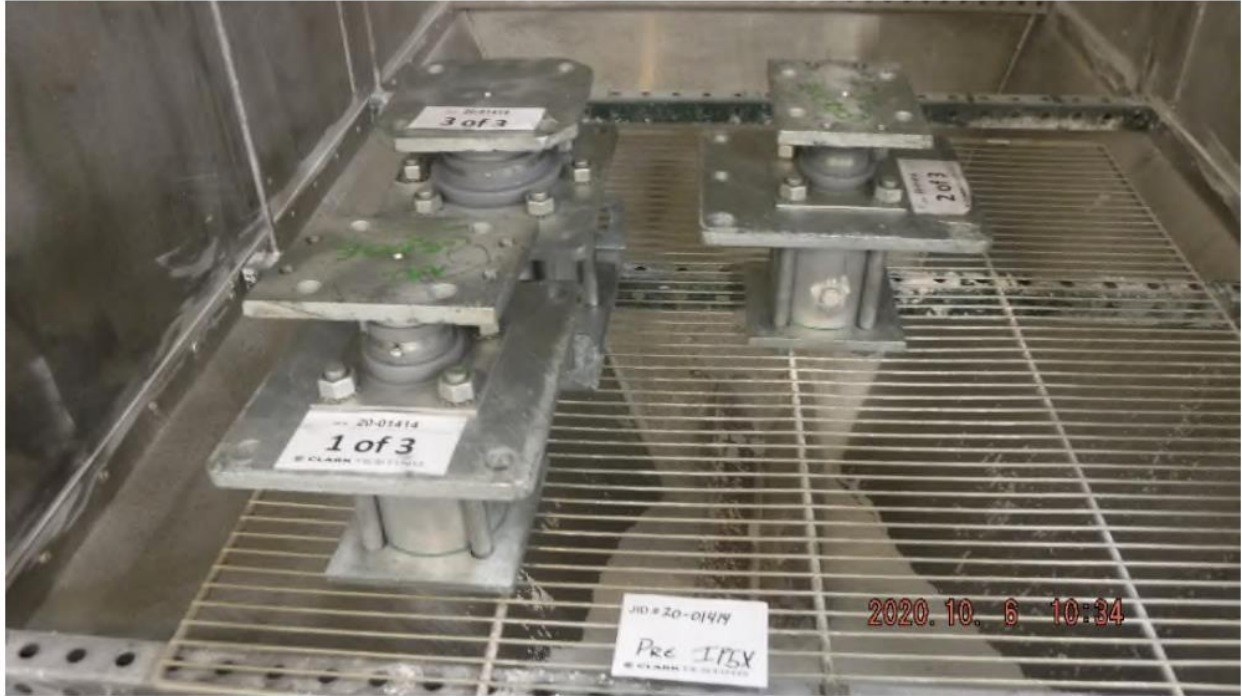
Figure 2: Dust Ingress Pre-Test Condition

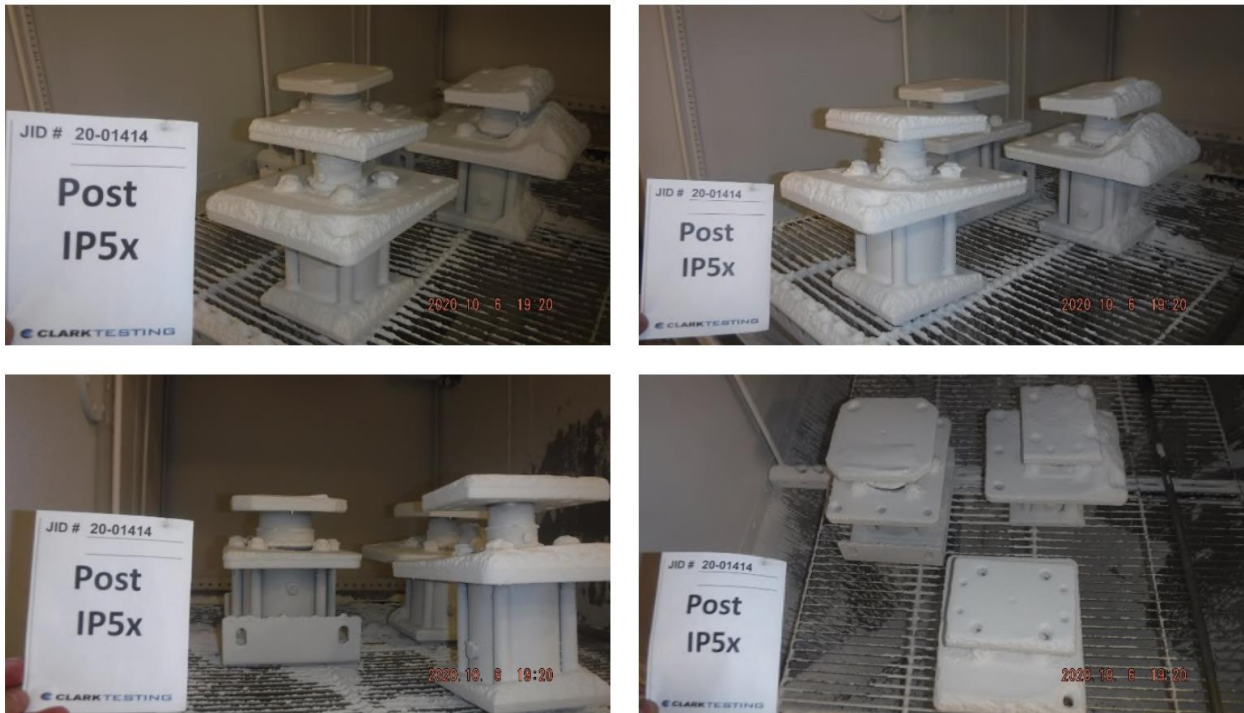
Figure 3: Dust Ingress Post-Test Condition

Post-test inspection showed no ingress of dust into the bearing assembly. Refer to “Post-Tests 1–4 Teardown” pictures on page 13.

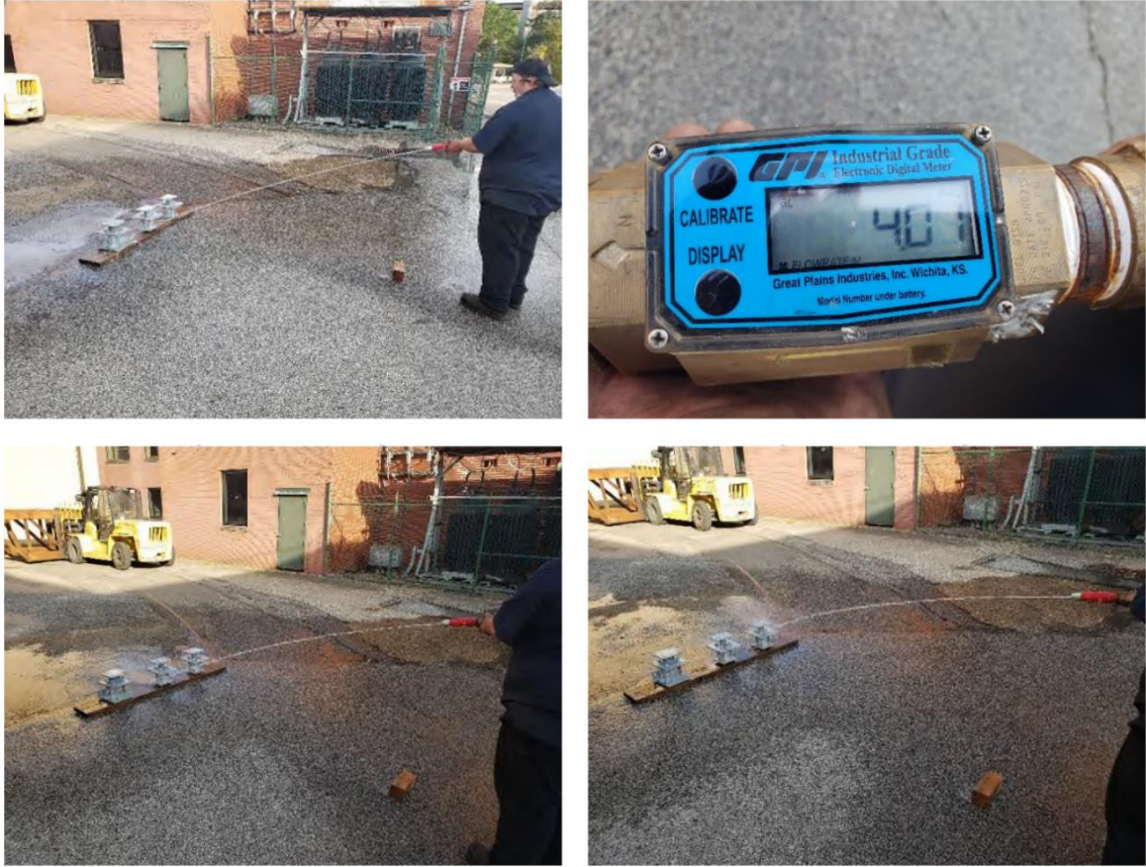
Figure 5: Water Ingress In-Process Testing

Name	Water Ingress
Goal	Prove resistance to water entry into bearing.
Description	Each bearing assembly was subjected to a 1 min/m ² (3-minute minimum) IPX5 water ingress test in accordance with IEC 60529. An IPX5 nozzle with the appropriate flow and test distance was used. Testing was performed on every side of each bearing that would be exposed to ingress when mounted in the field. Following the test, each bearing was allowed to drip dry for 10 minutes.
In-Service Condition	Heavy rain
Standard	IEC 60529
Duration	1-minute exposure (4 sides)
Lab	Clark Dynamic Test Laboratory
Location	Large, PA

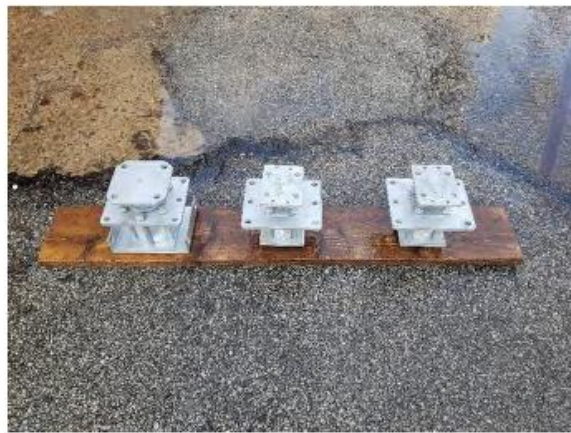
Figure 6: Water Ingress Post-Test Condition

Post-test inspection showed no ingress of water into the bearing assembly. Refer to “Post-Tests 1–4 Teardown” pictures on page 13.

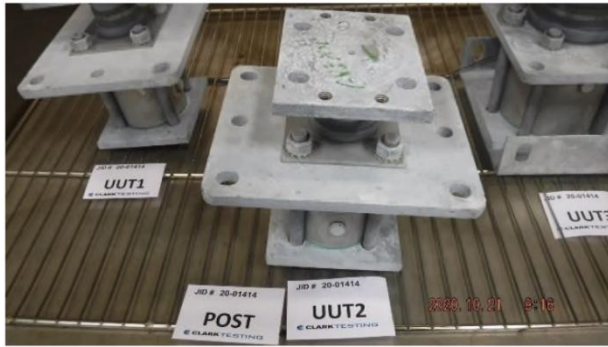
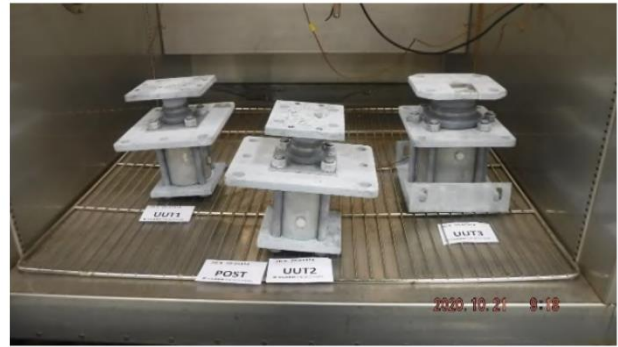
Figure 8: Humidity Post-Test Condition

Post-test inspection showed no internal condensation or corrosion due to high humidity. Refer to “Post-Tests 1–4 Teardown” pictures on page 13.

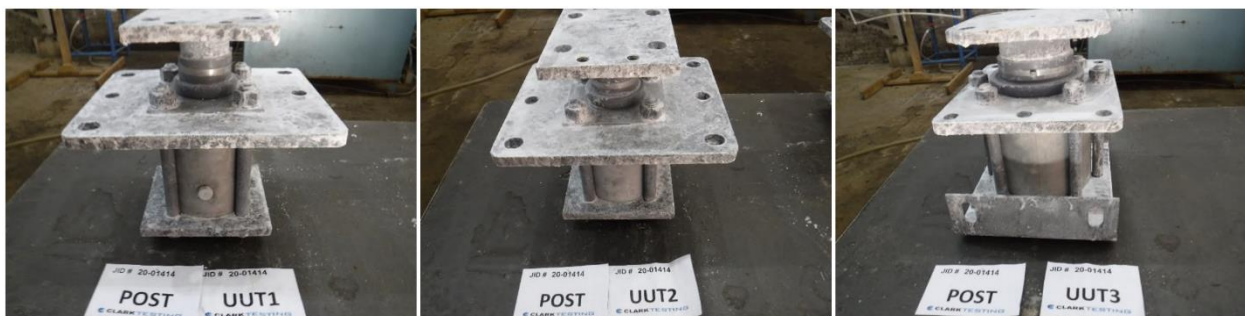
Figure 10: Salt Spray Post-Test Condition

Post-test inspection showed no ingress of salt or water into the bearing and no corrosion. Refer to “Post-Tests 1–4 Teardown” pictures on page 13.

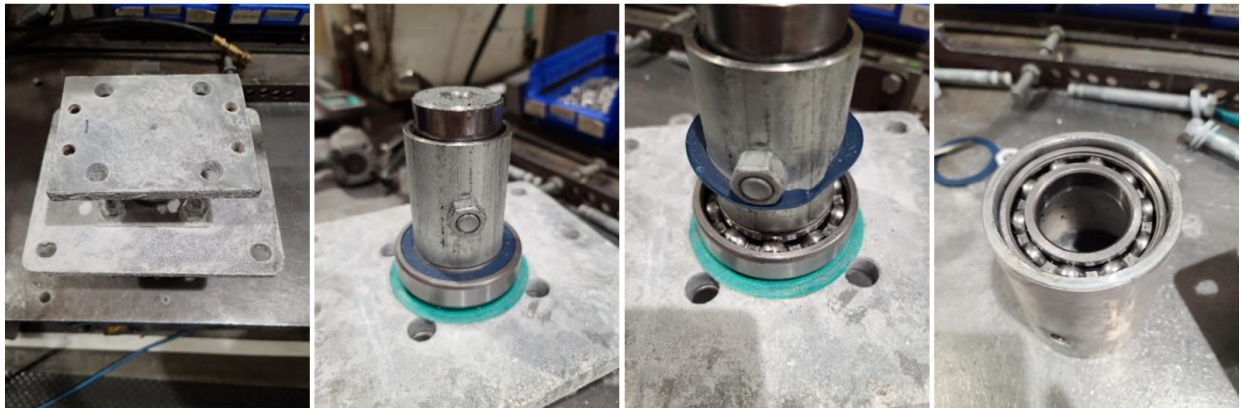
Figure 11: UUT1 Post-Tests 1–4 Interior and Bearing Condition

Following tests 1–4, the bearing assemblies were completely disassembled to inspect the inside surfaces for signs of dust, water, condensation, salt, or other contaminants. There were no signs of entry for any of these substances, and all bearings looked the same as when they were newly assembled. See Figures 11–13.

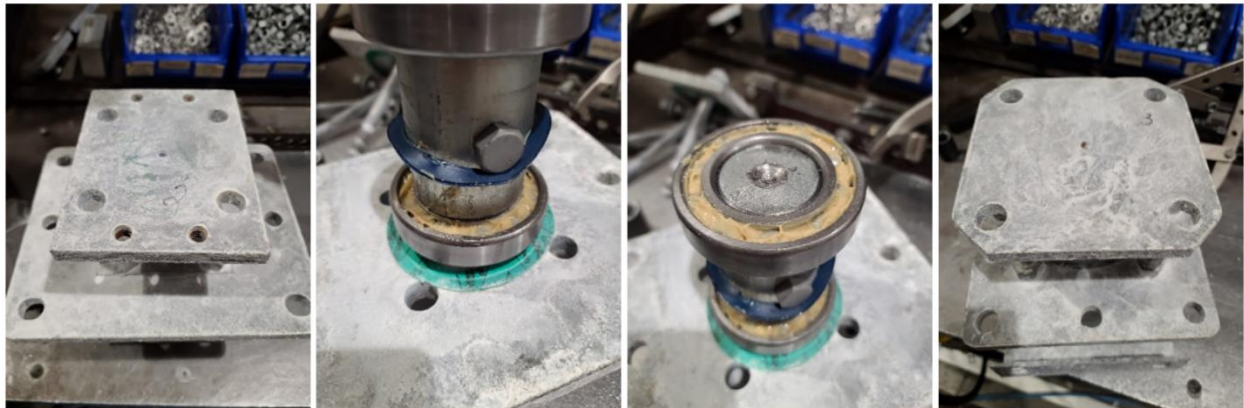
Figure 12: UUT2 Post-Tests 1–4 Interior and Bearing Condition

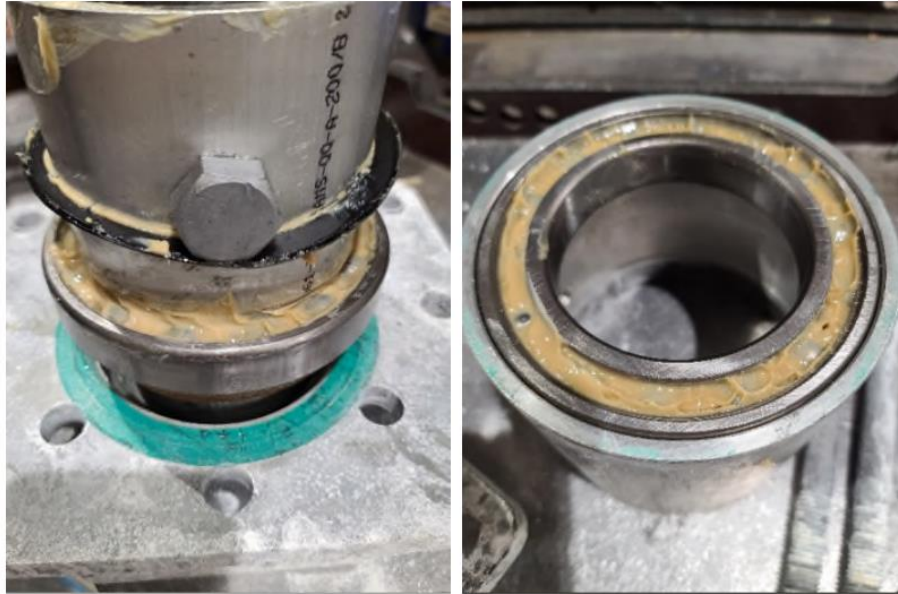
Figure 13: UUT3 Post-Tests 1–4 Interior and Bearing Condition

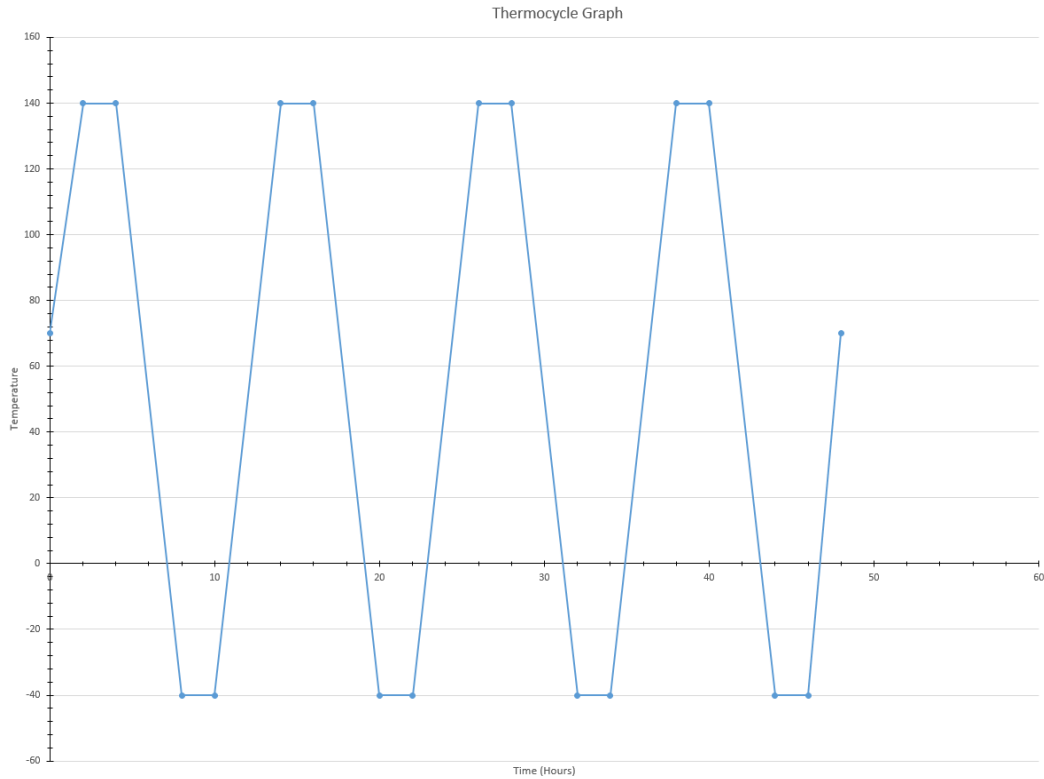
Figure 14: Thermocycle Temperature Profile Graph

Name	Temperature Shock
Goal	Prove there is no increase in operation torque with extreme temperature and relative humidity changes.
Description	Each bearing was subjected to a temperature and humidity profile that cycled from +140 °F at 90 % RH to -40 °F at 30 % RH. Each temperature was held for two hours, and then repeated.
In-Service Condition	Hot weather followed by a fast-moving cold front or cold rain
Standard	None
Duration	48 hours
Lab	Cleveland/Price Laboratory
Location	Trafford, PA

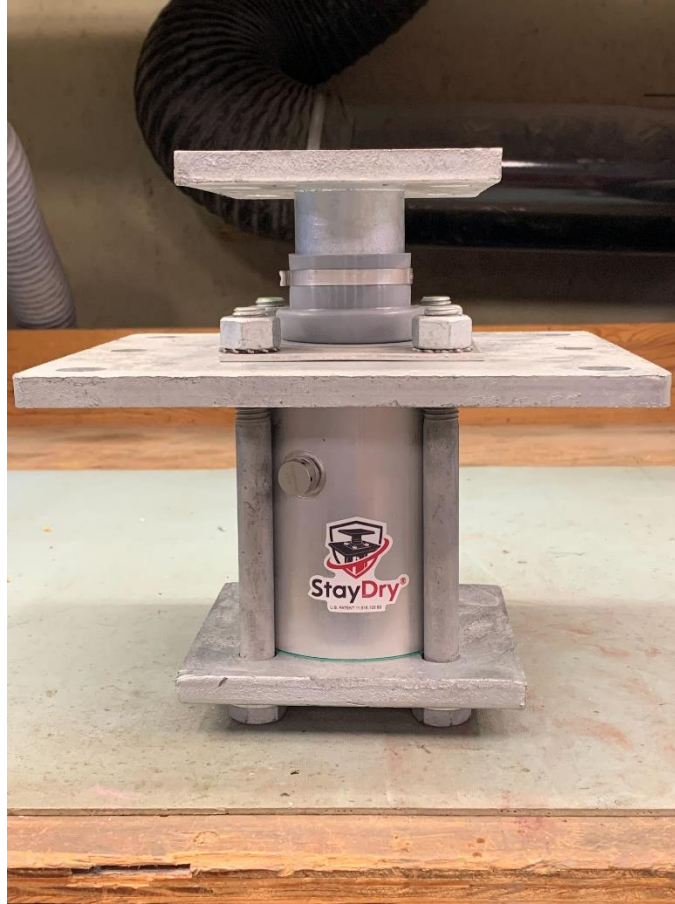
Figure 15: UUT4 Thermocycle Test Object

After four thermocycles, the bearing showed a decrease in operation torque at each of the four temperature check points. In addition, the increase in torque at low temperatures compared to room temperature was very acceptable with an increase of only 28 in-lb.

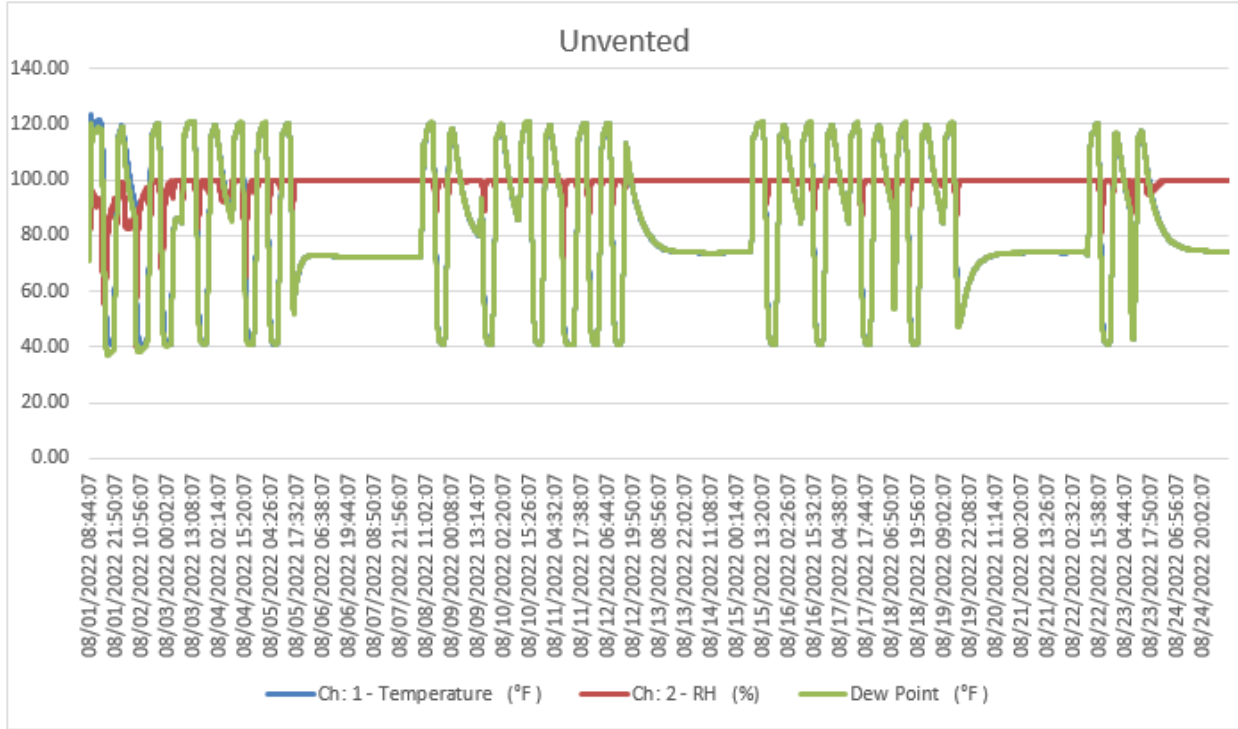
Figure 16: Unvented Bearing Temperature vs. Relative Humidity vs. Dew Point

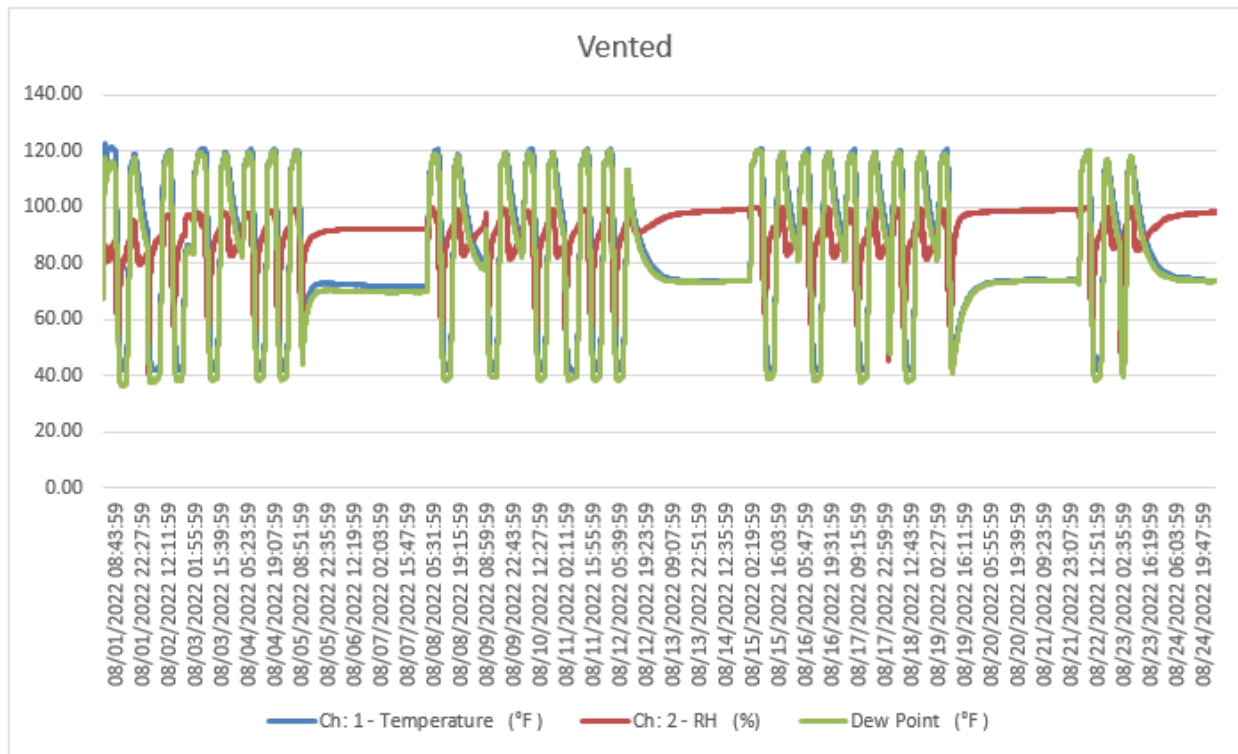
Figure 17: Vented Bearing Temperature vs. Relative Humidity vs. Dew Point

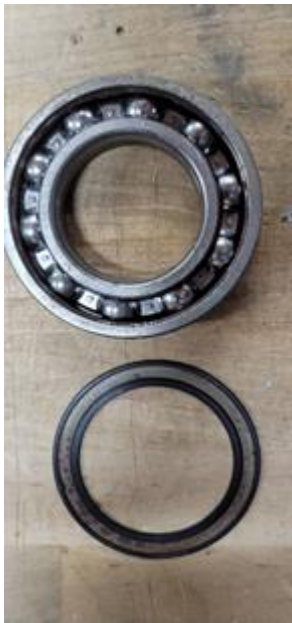
Figure 19: UUT5 Vented Bearing, Forced Humidity Post-Test Condition

Post-test inspection showed no rust on the bearings in the vented assembly and a considerable amount of rust on the bearings in the unvented assembly. The rotation of the bearing shaft on the unvented assembly was very rough due to corrosion of the metal surfaces of the bearing.

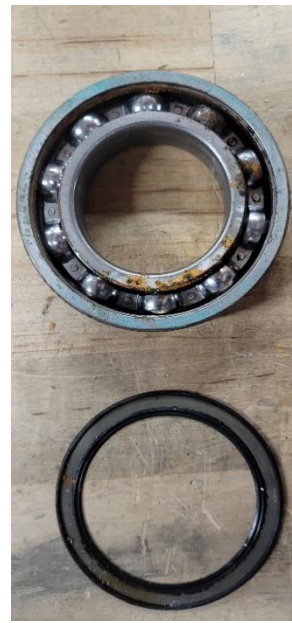
Figure 20: UUT6 Unvented Bearing, Forced Humidity Post-Test Condition

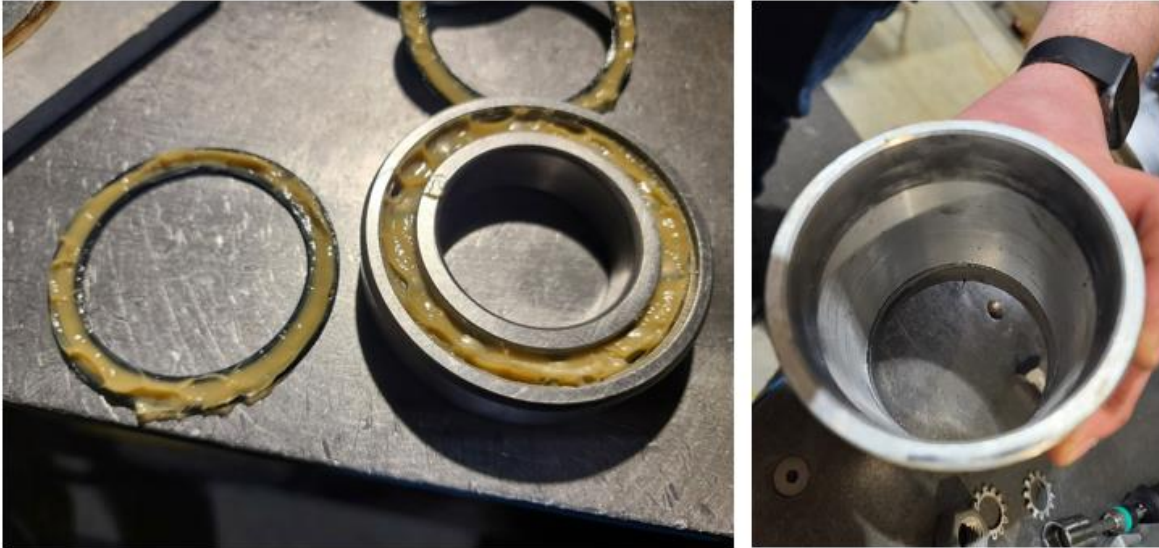
Figure 23: Field Test 2—UUT9 One-Year Inspection

A one year, post-test inspection showed no rust on the bearings in the vented assembly and a considerable amount of rust on the bearings in the unvented assembly even though there was grease to help prevent corrosion. The bearings from the vented assembly had smooth rotation while the bearings from the unvented assembly were completely frozen and unable to be rotated due to corrosion of the metal surfaces of the bearing.

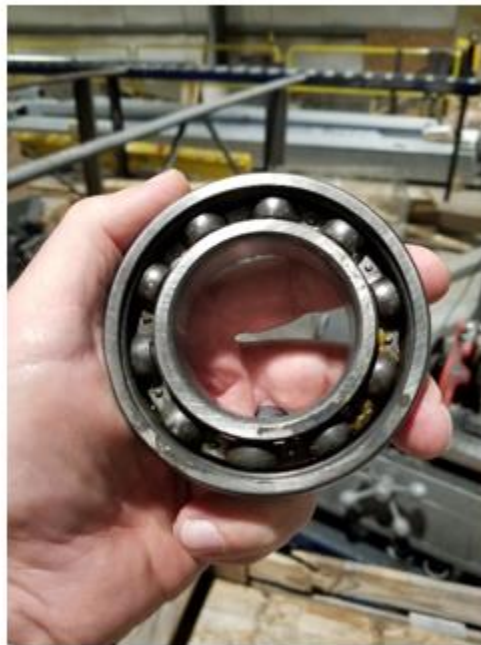
Figure 24: Field Test 2—UUT10 One-Year Inspection

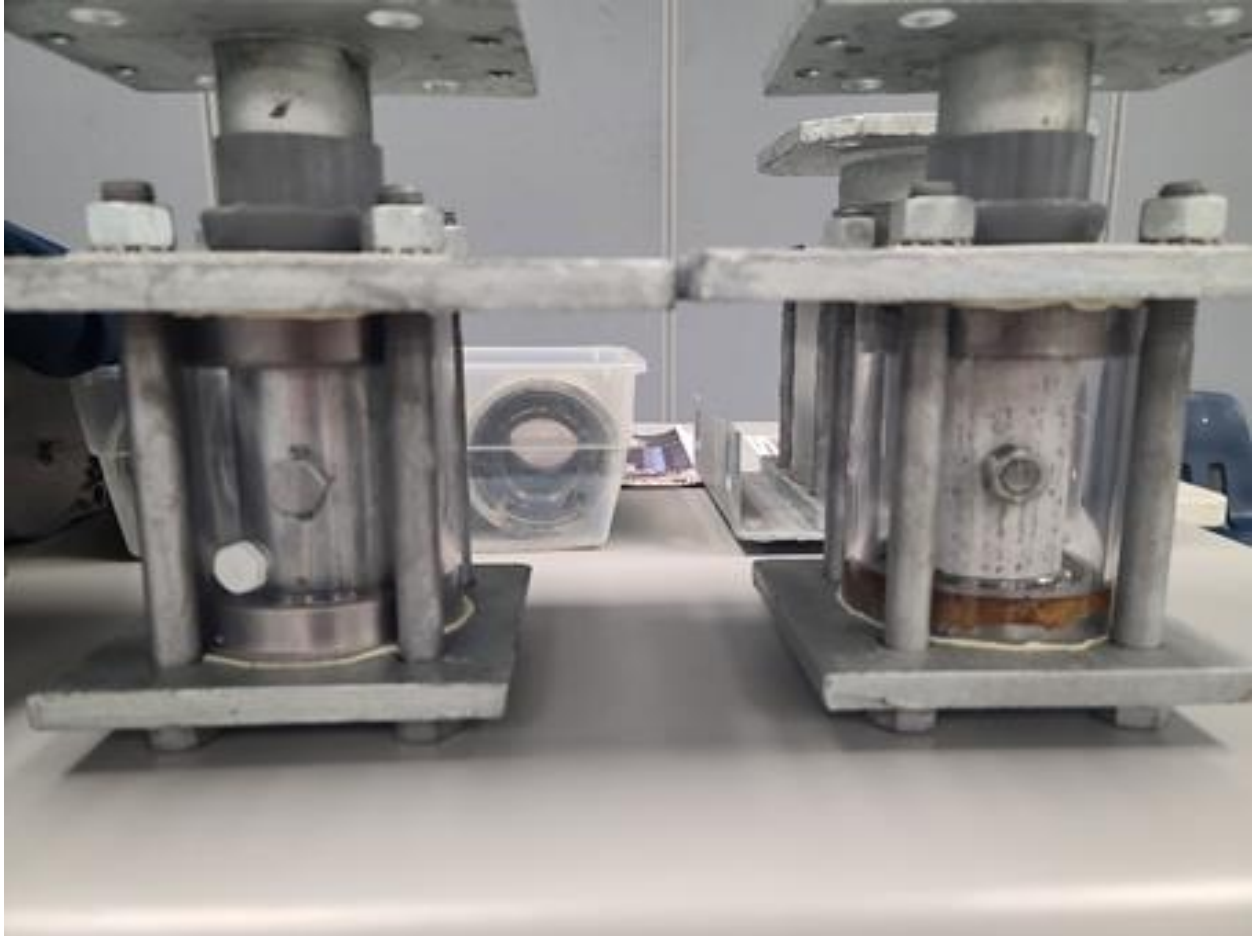
Figure 25: Field Test 3—UUT11 and UUT12 Six-Month Inspection

A six-month visual inspection showed that the unvented bearing assembly had white oxidation on the interior galvanized surfaces along with rust on the bearings. The vented bearing assembly showed no oxidation on the interior surfaces or corrosion of the bearings. Even after four years the bearing with the hydrophobic vent rotates smoothly but the unvented bearing shaft is not able to be rotated.

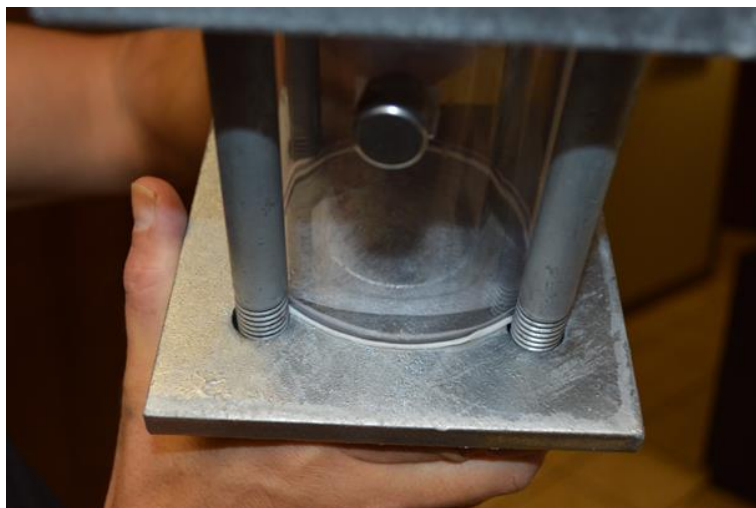
Figure 26: Field Test 4—Sealed, Vented Volume with One Teaspoon of Liquid Water

Name	Field Test 4
Goal	Prove ability of a sealed volume with a hydrophobic vent to allow liquid water to evaporate from inside.
Description	An open chamber was constructed with a clear, polycarbonate housing sealed with gaskets and two steel plates on each side, similar to the construction of a typical bearing. The assembly was held together with four bolts. A hydrophobic vent was mounted to the clear housing, and one teaspoon of liquid water was placed in the housing. The assembly was placed in a temperature-controlled, indoor office environment.
In-Service Condition	Water bypasses seals and enters bearing housing
Standard	None
Duration	118 days
Lab	Cleveland/Price Laboratory
Location	Trafford, PA

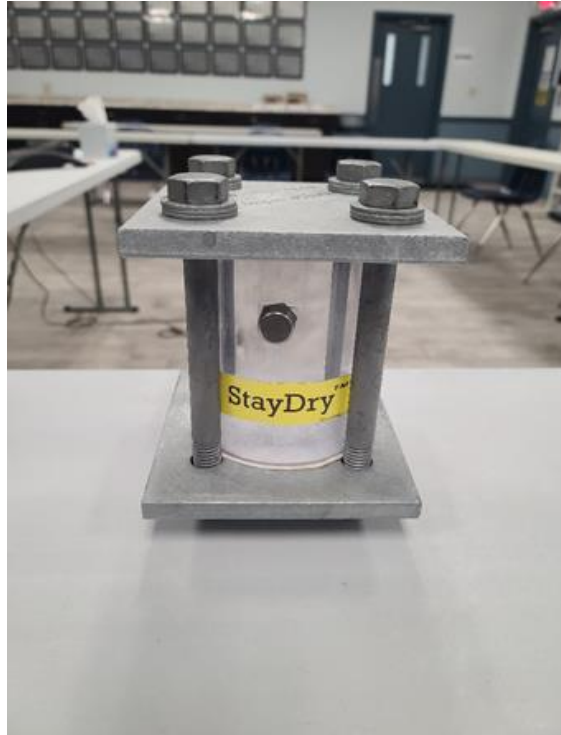
Figure 27: Field Test 4—118-Day Visual Inspection

After 118 days, the teaspoon of water was completely evaporated from the inside of the housing. The hydrophobic vent allowed the water vapor to flow from high water vapor concentration (inside) to low water vapor concentration (outside).
